**International Boundary and Water Commission
United States Section**

**Work Plan
Rio Grande Flood Control System Rehabilitation Program
at Lower Rio Grande Valley
November 15, 2004**

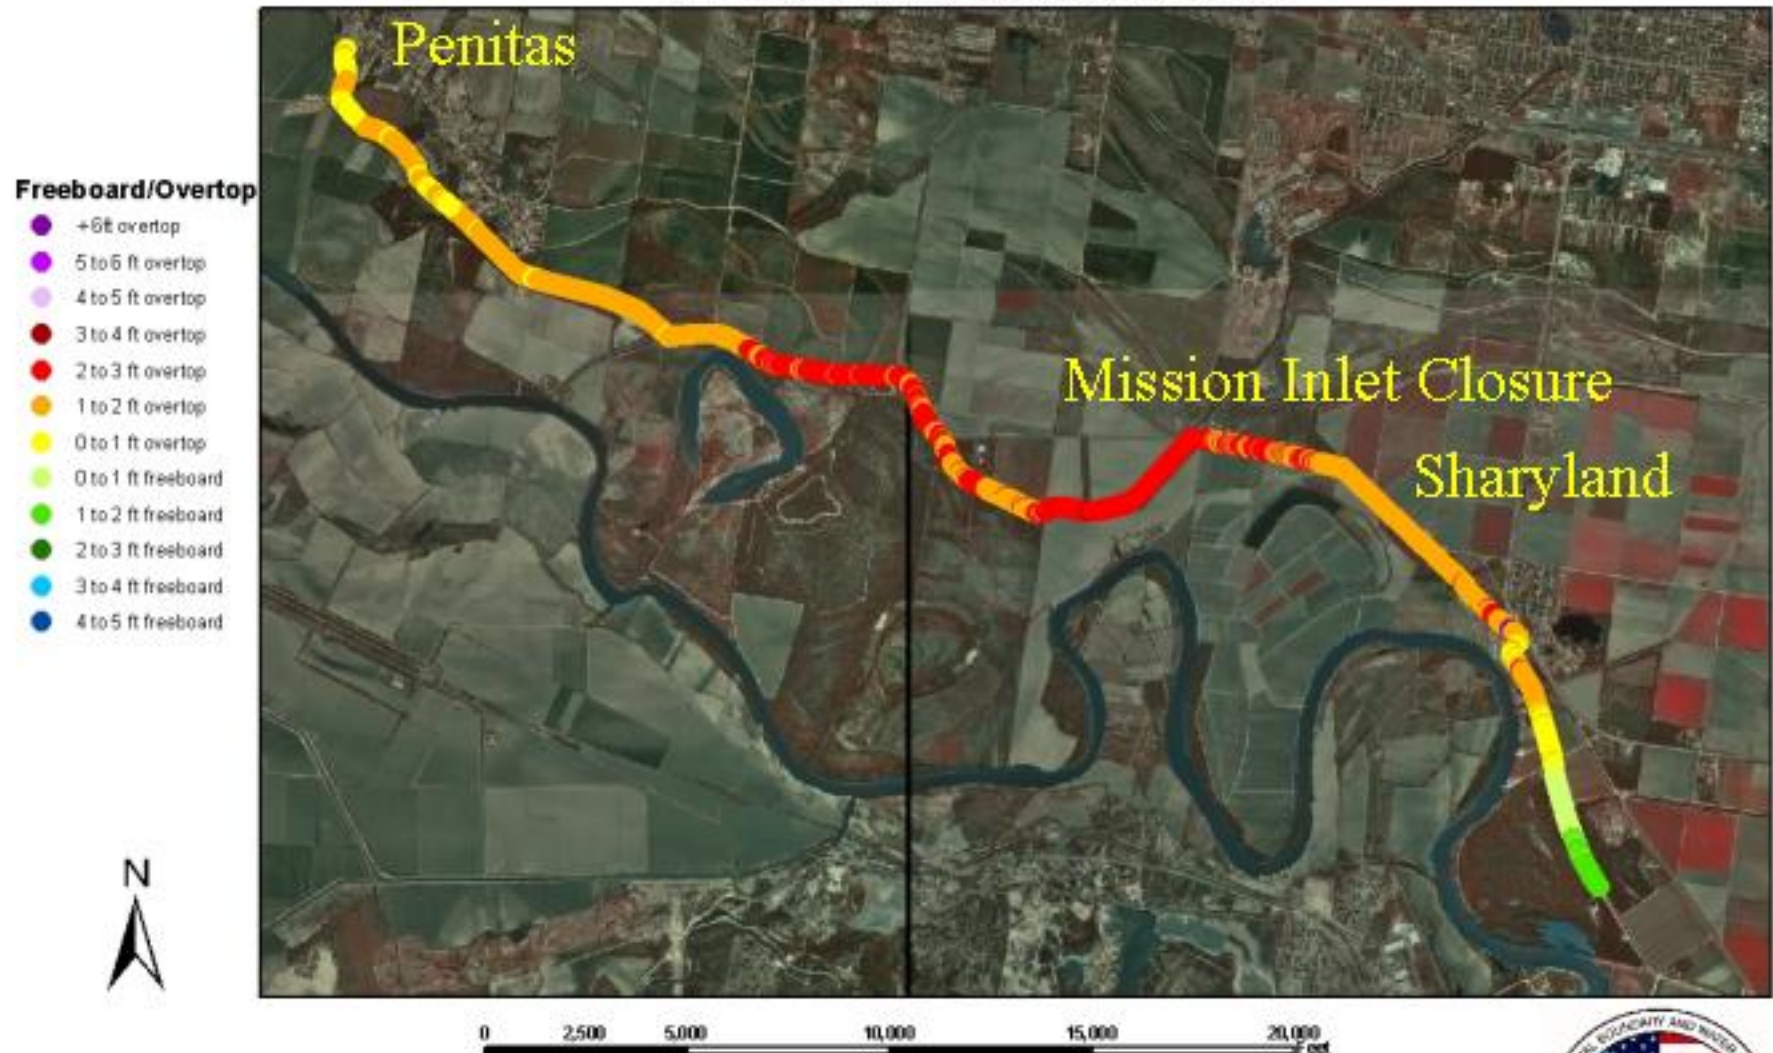
Lower Rio Grande Valley Levee Rehabilitation Penitas to Anzalduas Dam

The levee within this 9 mile reach is approximately 5 feet deficient in height. Levee protects several communities from Penitas to Anzalduas Dam including the residential/industrial interests of Sharyland. Marginal geology (subsurface) concerns exist within this reach of the levee. Estimated Construction Cost - \$15.5 million

- a. Levee Raising - non structural - 9 miles (\$15.5M)

Description - The levee within this 9 - mile reach is approximately 5 feet deficient in height. Levee protects several communities from Penitas to Anzalduas dam including

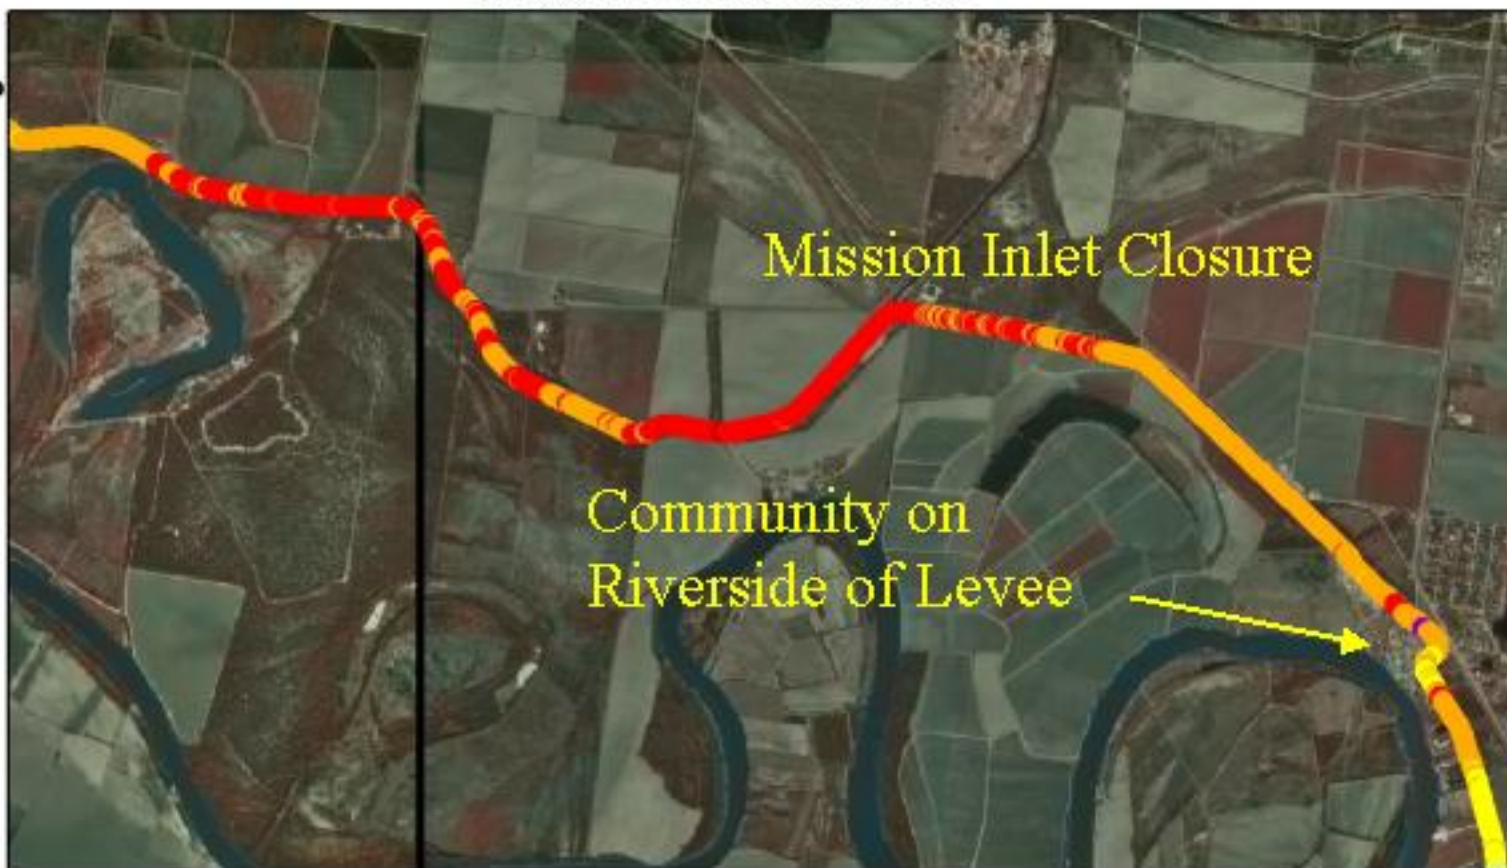
Lower Rio Grande Valley Levee Rehabilitation Mission Inlet Closure

Community on
Riverside of Levee

Initial investigations categorize the geology in the Mission Inlet closure vicinity as poor, thus warranting additional investigations. This area also has historical borrow areas located immediately adjacent to the levee toe. Since its closure, a development boom has occurred in the old Mission Floodway. Should the levee breach in this reach, extensive flood damages could be expected. If additional geotechnical investigations suggest corrective action, a subsurface barrier (slurry trench, sheet pilings) will most likely be the proposed alternative. Note: TXDOT has a project in this vicinity. Estimated Construction Cost - \$6.9 million

Description - Initial investigations categorize the geology in the Mission Inlet closure vicinity as poor, thus warranting additional investigations. This area also has historical borrow areas located immediately adjacent to the levee toe. Since its closure, an explosion of development has occurred in the old Mission Floodway. Should the levee breach in this reach, extensive flood damages can be expected. If additional geotechnical investigations suggest corrective action, a subsurface barrier (slurry trench, sheet pilings) will most likely be the proposed alternative. Note: TXDOT has a project in this vicinity.

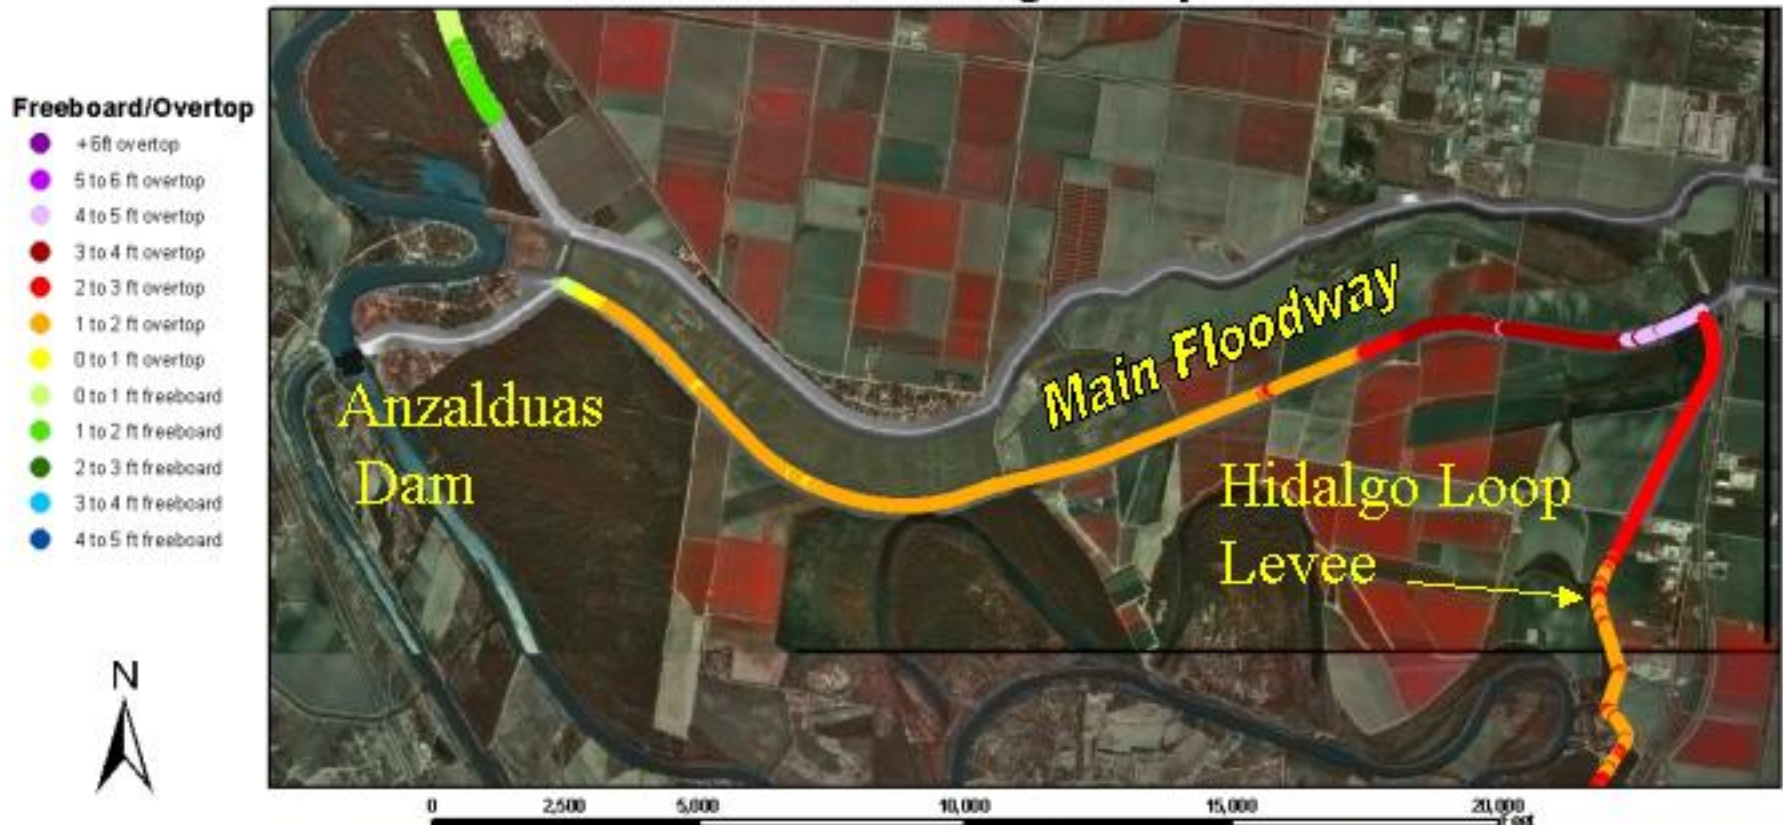
Lower Rio Grande Valley Levee Rehabilitation South Levee Banker Floodway Anzalduas to Hidalgo Loop Levee

This levee reach is referred to as the Common Levee and ties into Anzalduas Dam. The purpose of Anzalduas Dam is to divert the U.S. allocation of floodwaters into the Main Floodway. The Common Levee serves as the southern levee of the Main Floodway and also provides protection from the mainstem flows of the Rio Grande. The Common Levee will have water on both sides of the levee during a flood event. Failure of the Common Levee will result in uncontrolled flows within the Main Floodway and along the Rio Grande below Anzalduas Dam. The Common Levee is approximately 6 feet deficient in height and has marginal structural problems. It is assumed that 1.5 miles of this levee will require slurry trench rehabilitation. Estimated Construction Cost - \$12.2 million

Description - This levee reach is referred to as the Common Levee and ties into Anzalduas Dam. The purpose of Anzalduas Dam is to divert the U.S allocation of floodwaters into the Main floodway. The Common Levee serves as the southern levee of the Main Floodway and also provides protection from mainstem flows of the Rio Grande. The Common Levee will have water on both sides of the levee during a flood event. Failure of the Common levee will result in uncontrolled flows below Anzalduas Dam. The Common Levee is approximately 6 feet deficient in height and has marginal structure problems. It is assumed that 1.5 miles of this levee will require rehabilitation using slurry trench techniques.

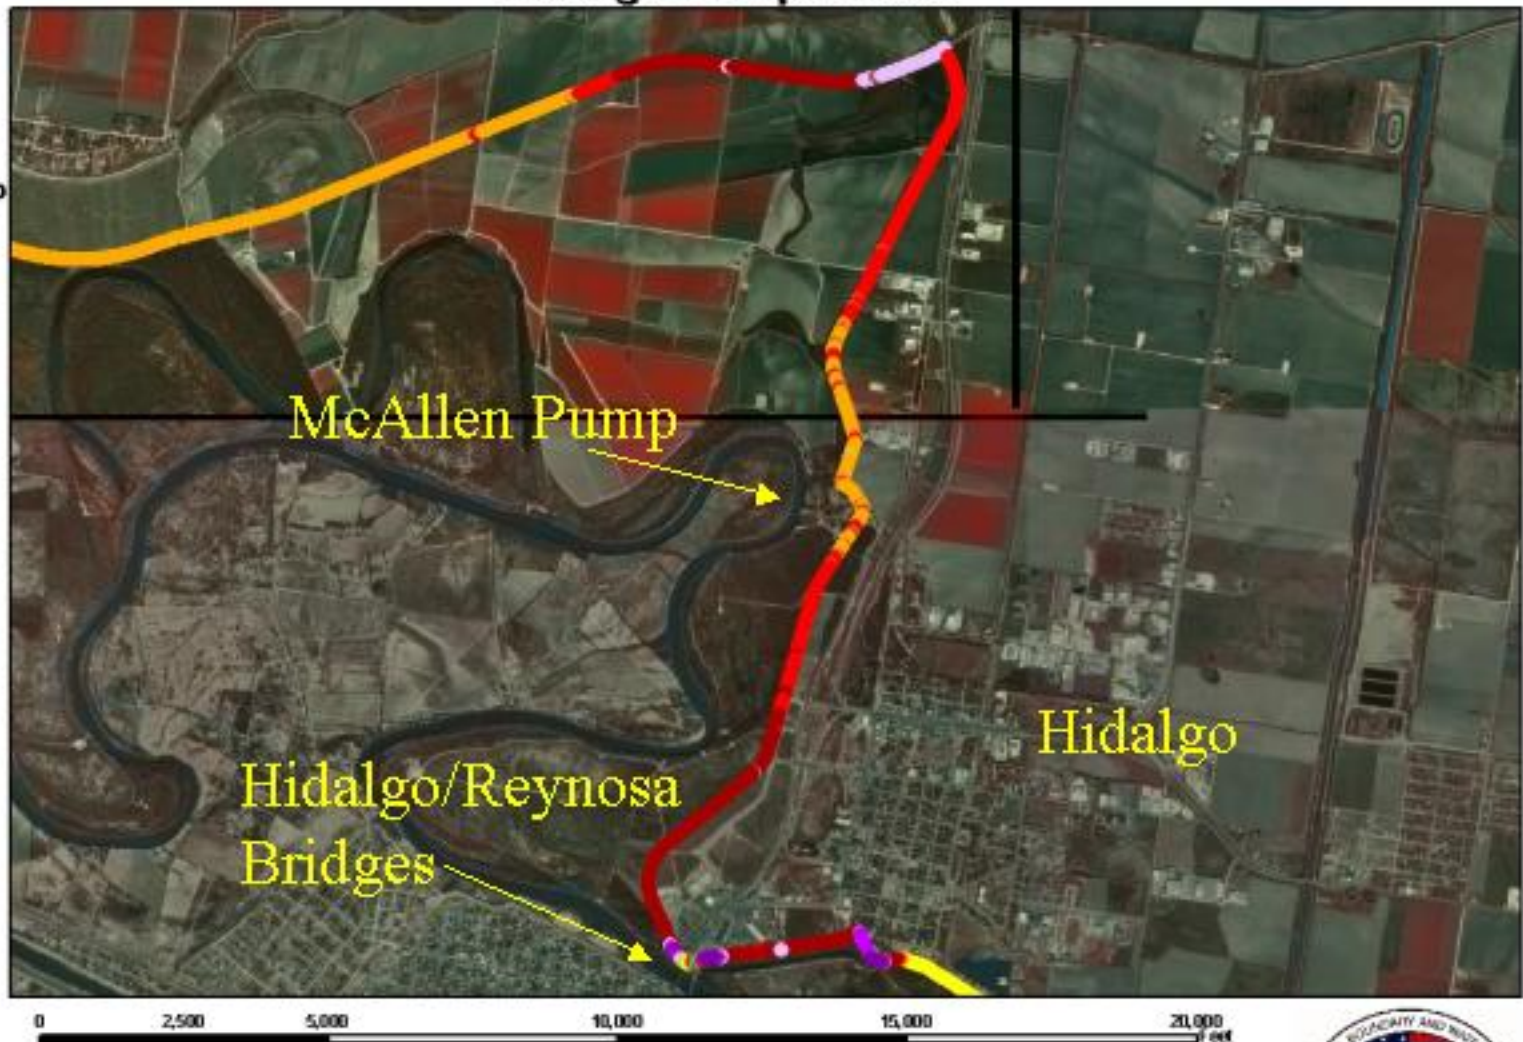
Lower Rio Grande Valley Levee Rehabilitation Hidalgo Loop Levee

Levee reach, commonly referred to as the Hidalgo Loop levee, ties into the south levee of the Main Floodway and continues in a southerly direction for 3.5 miles to the Hidalgo/Reynosa bridges. Levee protects the city of Hidalgo from flooding. Levee is approximately 6 feet deficient in height throughout the reach, with only marginal structural integrity problems. Estimated Construction Cost - \$6 million

- a. Main Floodway South Levee to Hidalgo/Reynosa Bridge - 3.5 miles (\$6.0M)

Description - Levee reach, commonly referred to as the Hidalgo Loop levee, ties into the south levee of the Main Floodway and continues in a southerly direction for 3.5 miles to the Hidalgo/Reynosa bridges. Levee protects the city of Hidalgo from flooding. Levee is approximately 6 feet deficient in height throughout the reach, with only marginal structural integrity problems.

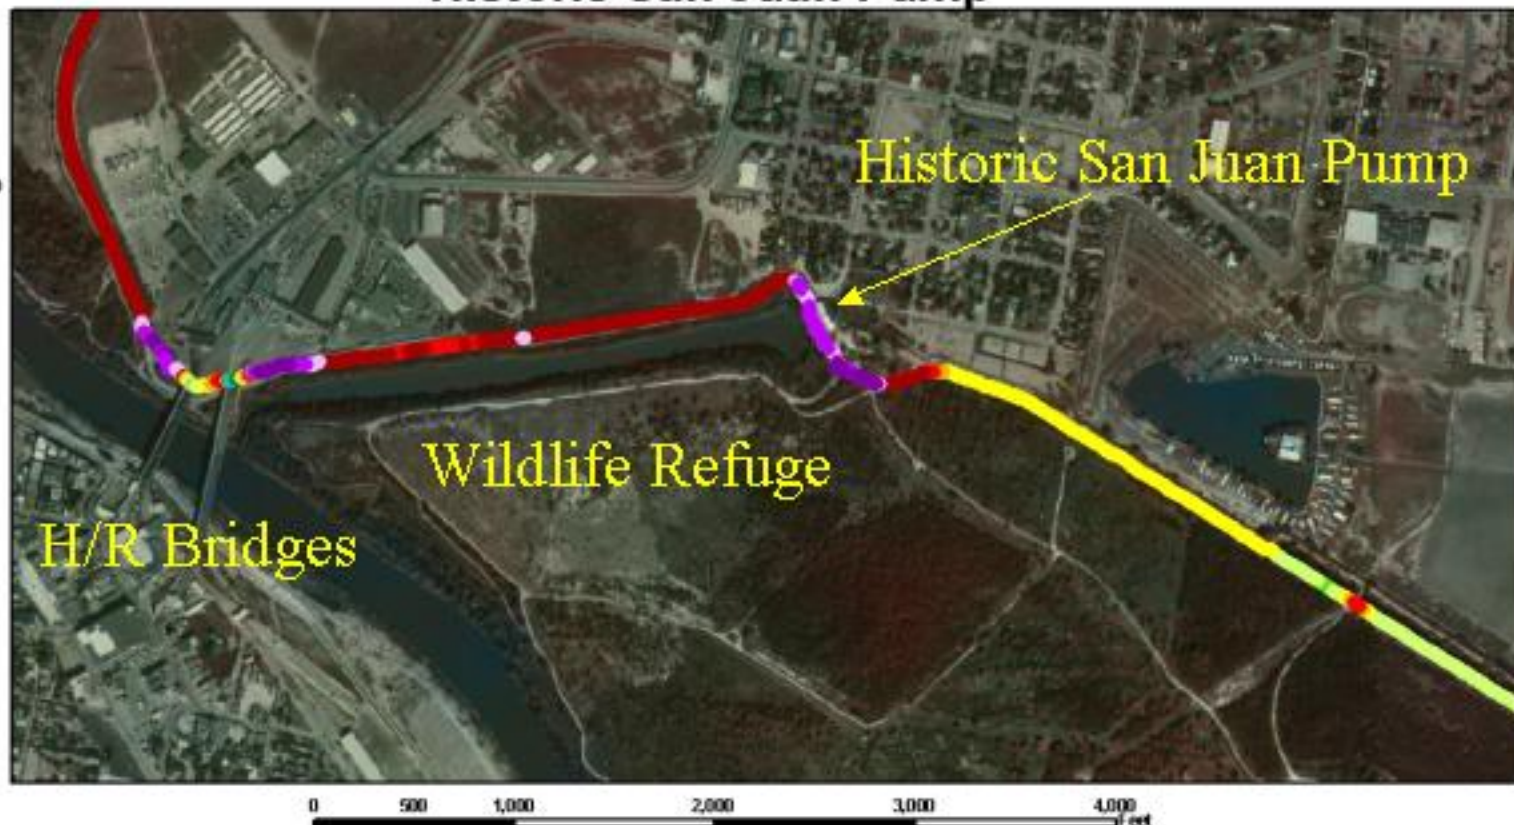
Lower Rio Grande Valley Levee Rehabilitation Historic San Juan Pump

Existing levee extends approximately 0.65 miles from the Hidalgo/Reynosa bridges east to beyond the historic San Juan pumping station. The middle segment of the levee reach is approximately 6 feet deficient in height and considered primarily a levee raising project. However, flood protection is approximately 9 feet deficient in height near the bridges and the historic pump house. These areas will require alternative flood protection methods such as retaining walls due to limited ROW and historic considerations. One alternative would be to relocate the levee from the north side of the historic pump intake canal to the south side of the canal adjacent to the wildlife refuge. This would require construction of 0.65 mile of new levee, 0.35 mile of levee raising and special consideration at the canal crossing and in the vicinity of the bridges. This alternative would reduce adverse impacts to the hike and bike trail and historic area. Estimated Construction Cost - \$2.2 million.

- b. New Levee - 1.0 mile (\$2.2M)

Description - Existing levee extends approximately 0.65 miles from the Hidalgo/Reynosa bridges east to beyond the historic San Juan pumping station. The middle segment of the levee reach is approximately 6 feet deficient in height and considered primarily a levee raising project. However, flood protection is approximately 9 feet deficient in height near the bridges and historic pump house. These areas will require alternative flood protection methods such as retaining walls due to limited ROW and historic considerations. One alternative would be to relocate the levee from the north side of the historic pump intake canal to the south side of canal adjacent to the wildlife refuge. This would require construction of 0.65 miles of new levee, 0.35 mile of levee raising, and special considerations at the canal crossing and in the vicinity of the bridges. This alternative would reduce adverse impacts to the hike and bike trail and historic area.

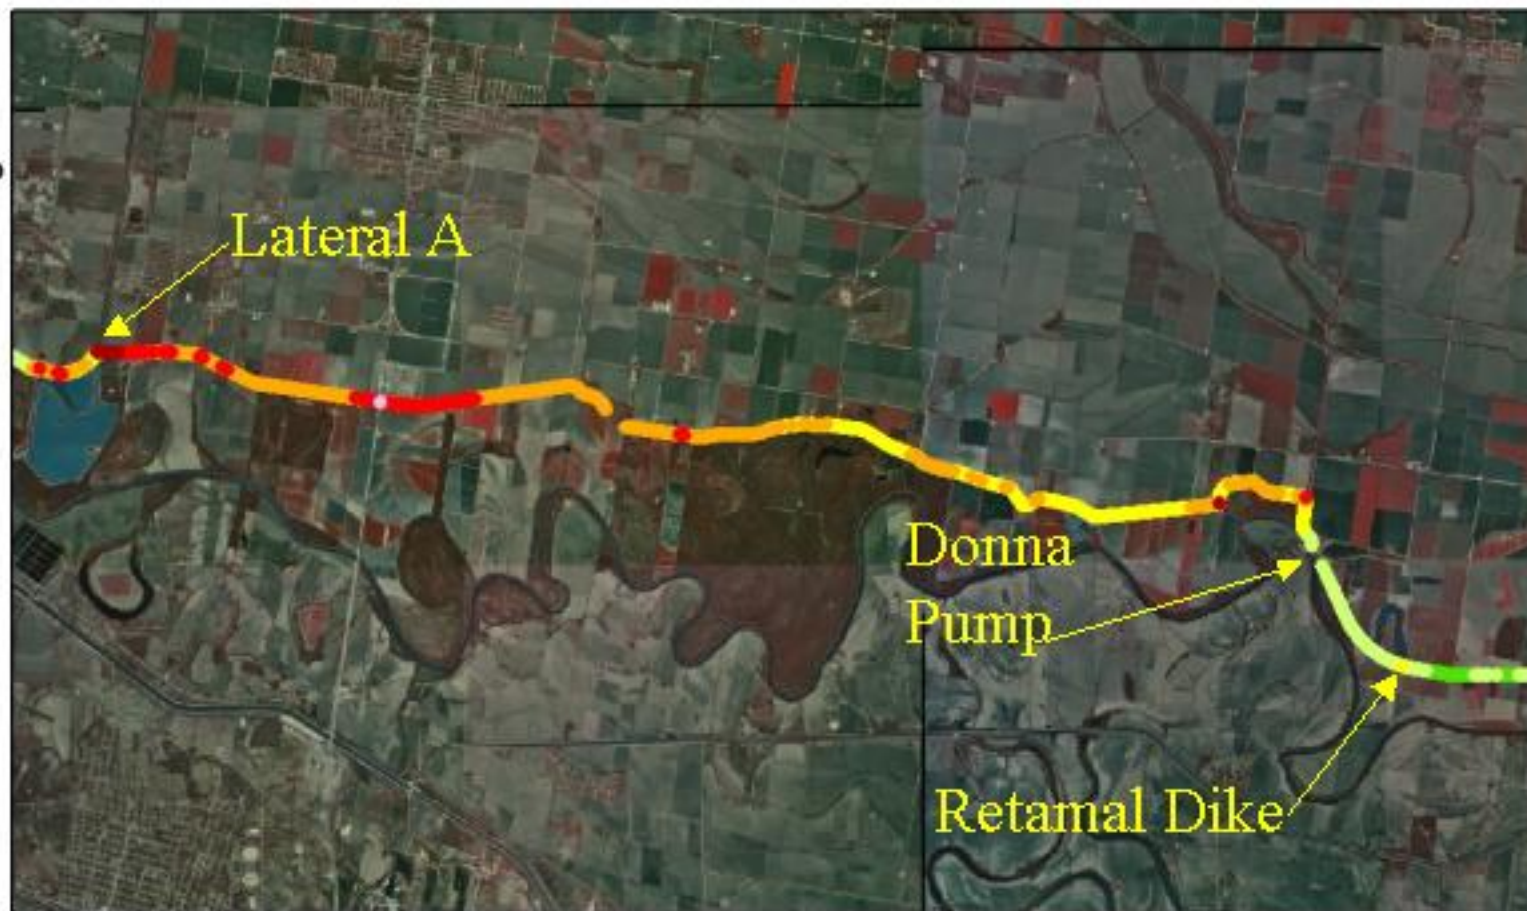
Lower Rio Grande Valley Levee Rehabilitation Lateral A to Donna Pump Station

The levee is approximately 4.5 feet deficient in height with little structural problems within this reach. An estimate of \$1.2 million/mile was used for this reach due to lower levee raising required. Estimated Construction Cost - \$16.5 million

Description - The levee is approximately 4.5 feet deficient in height with little structural problems within this reach. An estimate of \$1.2M/mile was used for this reach due to lower levee raising required.

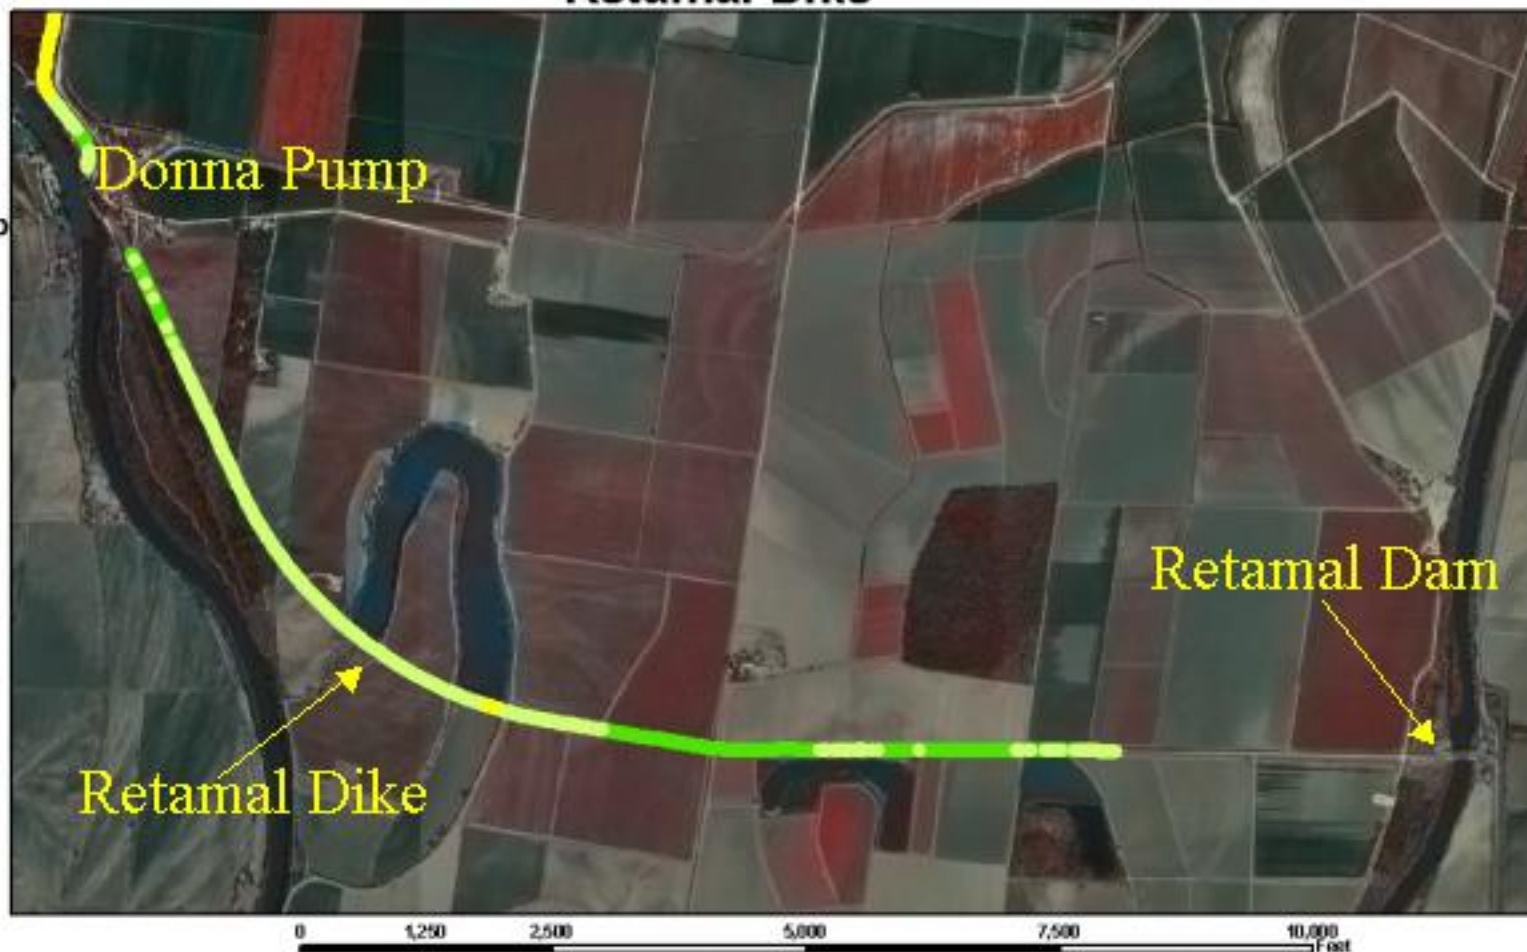
Lower Rio Grande Valley Levee Rehabilitation Retamal Dike

The levee reach connects Retamal Dam into the levee system and is commonly referred to as Retamal Dike. The purpose of Retamal Dam is to divert flood flows into the Mexican floodway. Failure of Retamal Dike would result in uncontrolled flows downstream of Retamal Dam. Initial geotechnical investigations indicated structural integrity problems with Retamal Dike. Large cracks exist on the surface and within the core of the levee. Scheduled investigations should provide additional insight regarding the integrity of the levee. Possible corrective action includes slurry trench, sheet pilings, or reconstruction of the levee along the 3 mile stretch of the dike. Estimated Construction Costs - \$6.0 million

Description - This levee reach connects Retamal Dam into the levee system and is commonly referred to as Retamal Dike. The purpose of Retamal Dam is to divert flood flows into the Mexican floodway. Failure of Retamal Dike would result in uncontrolled flows downstream of Retamal Dam. Initial geotechnical investigations indicated structural integrity problems with Retamal Dike. Large cracks exist on the surface and within the core of the levee. Additional investigations scheduled for the latter part of this year should provide insight into the integrity of the levee. Some worst - case scenario alternatives would be construction of a slurry trench, sheet pilings, or reconstruction of the levee along the 3 mile stretch of the dike.

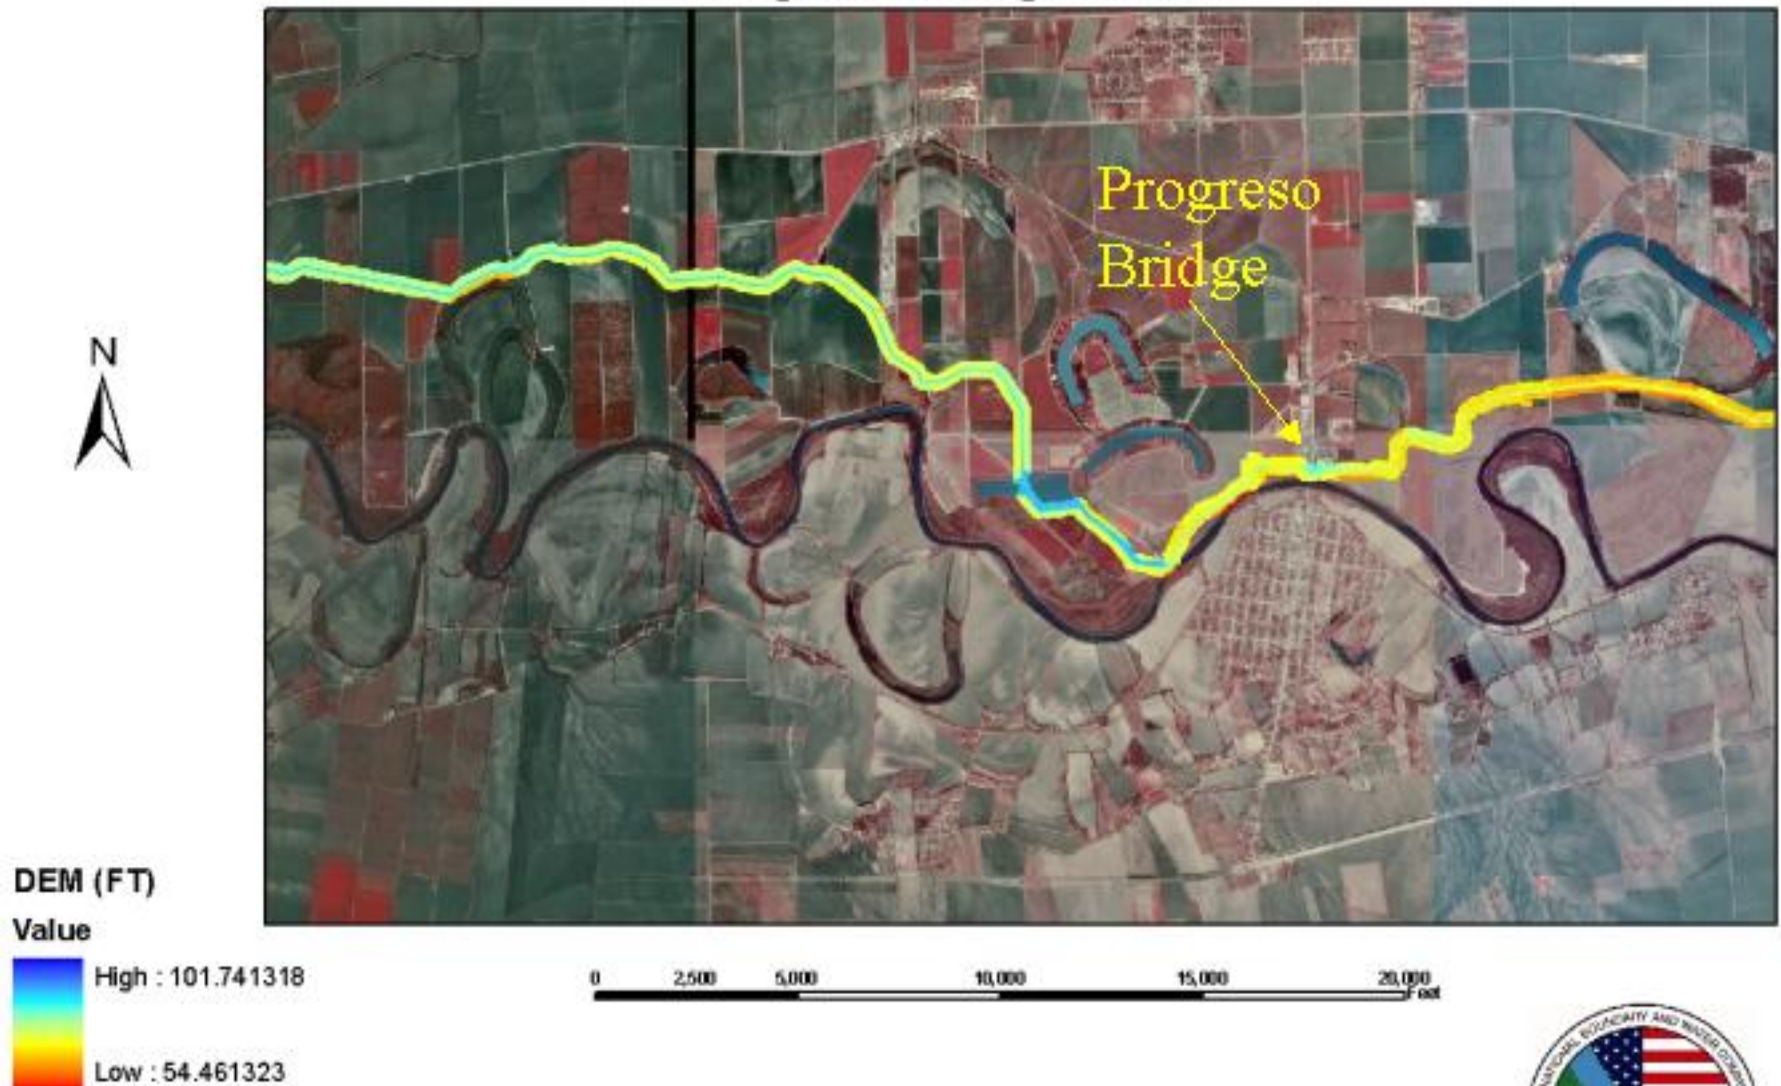
Lower Rio Grande Valley Levee Rehabilitation Progreso Bridge Reach

Initial geotechnical investigations indicated levee structural integrity concerns both upstream and downstream of Progreso bridge which may warrant further geotechnical investigations.
Estimated Construction Cost - \$9.9 million
